# Manhole Inspection Summary

Manhole # S11Y\_\_010MH

Insp Date: **12/11/08 11:36 AM**

**Location** Address: **1202 S Caton Ave**

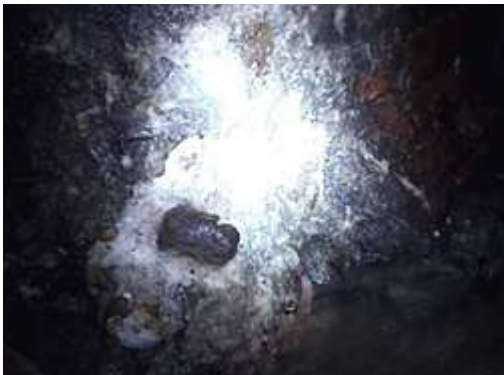
Misc

debris on bench and in channel

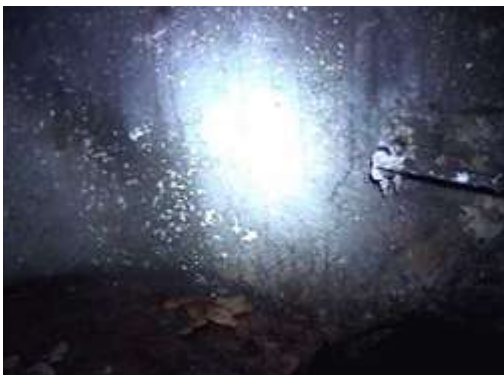
Defect 4

**Surcharge** ☒ **Evidence Of Surcharge** Depth: **1** (ft.) ☐ Active Surcharge Present

evidence of surcharge at 1

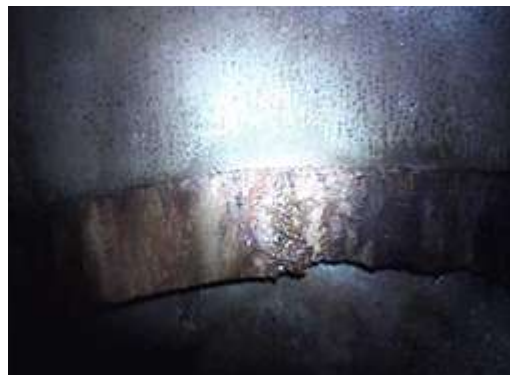
Defect 3

Infiltration: ☐ None ☒ **Joint** ☐ Cracks ☐ Mortar ☐ Roots ☐ Wall

infiltration at the corbel and barrel joint

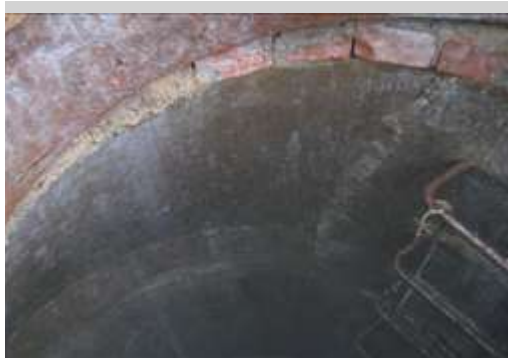
Defect 2

Condition: ☐ Sound ☐ Cracked ☐ Root Intrusion ☒ **Loose Brick** ☐ Deteriorated

loose bricks under frame, infiltration at joint

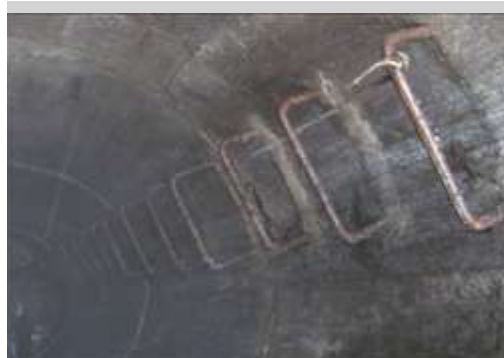
Defect 1

**Steps** Count: **15** Missing: **0** ☒ **Corroded**

corroded rungs infiltration along corbel wall
